General Information

Make	Suzuki	Model	Other
YOM	2018	Mileage	276,610
Registration No.	BLN-401	Chassis No.	NF1AVK31H10015823
CC	undefined	Transmission	Manual
Fuel Type	Petrol	Type of Body	Hatchback
Colour	White	Grade	undefined
Expiry Revenue license	06-04-2024	Expiry Insurance	06-04-2024

Body / Panel Condition

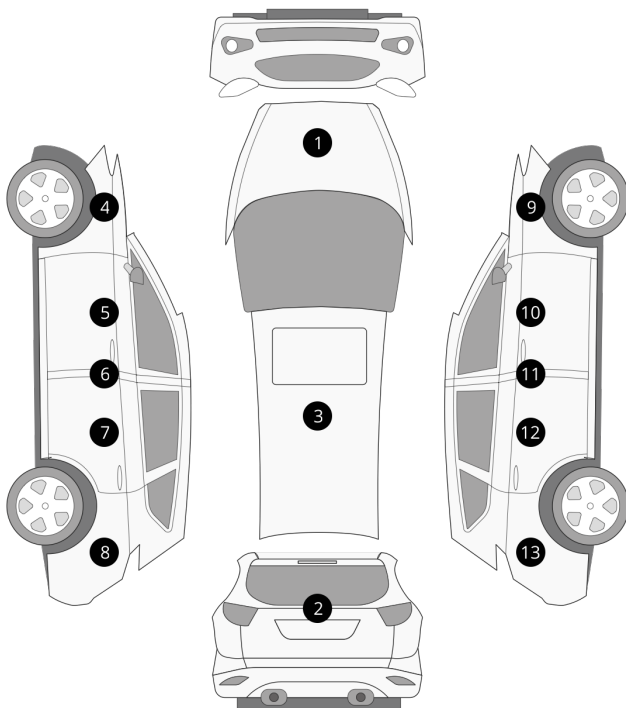
#	Area	Thickness(um)			
		Average	Value1	Value2	Value3/4
1	Bonnet	5.1	4	5	6
2	Boot Lid	4.3	4	5	4
3	Roof	4.2	4	5	4/4
4	Left Front Fender	9.3	5	6	16
5	Left Front Door	12.8	9	19	11
6	Center Panel Left				
7	Left Rear Door	4.3	5	4	4
8	Left Back Panel	4.1	4	4	4
9	Right Front Fender	4.5	4	5	5
10	Right Front Door	4.7	4	4	6
11	Center Panel Right				
12	Right Rear Door	13.8	28	6	7
13	Right Back Panel	5.3	4	6	5

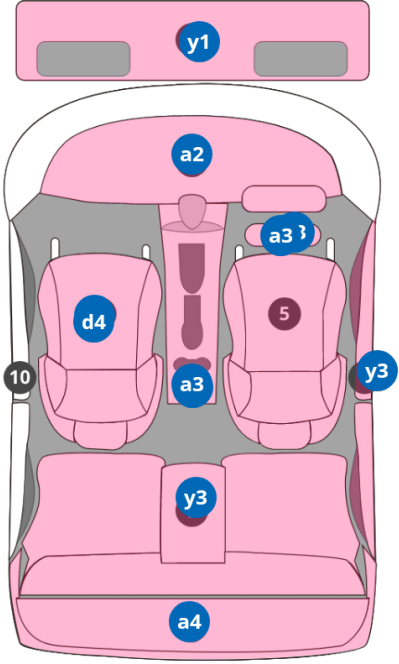
Interior Evaluation : C	Exterior Evaluation : B-

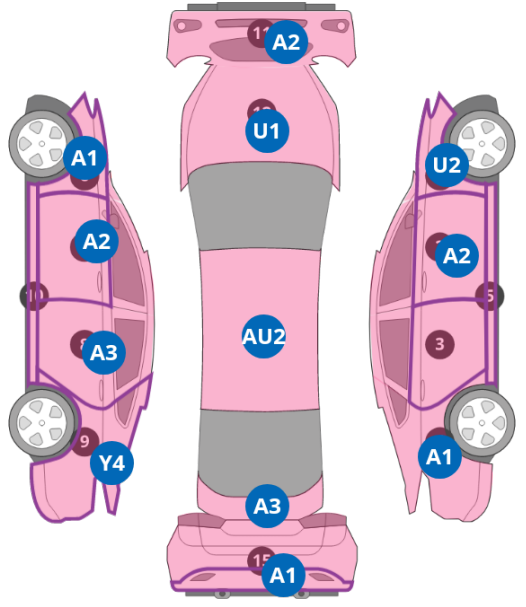
<p>A : Scratch AU : Scratch & Dent B : Modified C : Corrosion G : Stone chip P : Faded S : Rust SC : Rust & Corrosion U : Dent X : Defective Y : Crack, Gap</p>
<p>Remarks Ceiling - Grime - Minimal / Dashboard - Worn, Scratch, Cut, Crack - Small / Carpet - Loose, Deformed, Grime - Medium / Right Front Floor Lag - Cut, Crack - Medium / Right Front Seat Knobs - Stuck - Yes / Right Front Trim - Grime - Medium / Left Front Seat - Grime - Minimal / Left Front Seat belt - Loose, Deformed, Grime - Large / Console - Worn, Scratch, Cut, Crack - Minimal / Knobs - Worn, Peel, Crack - Medium / Audio System - Stuck - Yes / Rear Seat - Grime - Medium / Trunk Room - Worn, Scratch, Cut, Crack - Large</p>	<p>Remarks Right Front Door - Repair Traces - Yes / Right Step and Side Spoiler - Repair Traces - Yes / Right Front Fender - Repair Traces - Yes / Left Front Fender - Repair Traces - Yes / Left Front Door - Repair Traces - Yes / Left Step and Side Spoiler - Repair Traces - Yes / Left Rear Door - Repair Traces - Yes / Left Rear Fender - Repair Traces - Yes / Rear End Panel - Repair Traces - Yes / Right Rear Door - Repair Traces - Yes / Right Front Fender - Dent - Small / Right Rear Door - Scratch - Small / Right Rear Fender - Scratch - Minimal / Left Front Fender - Scratch - Minimal / Left Front Door - Scratch - Small / Left Rear Door - Scratch - Medium / Left Rear Fender - Crack, Gap - Large / Roof - Scratch & Dent - Small / Trunk Hood, Rear Gate - Scratch - Medium / Rear Bumper, Lamps, Panels - Scratch - Minimal / Bonnet, Headlight - Dent - Minimal / Front Bumper and Grille - Scratch - Small</p>
