General Information

Make	Suzuki	Model	Other
YOM	2008	Mileage	381,840
Registration No.	LED-08-1106	Chassis No.	421802
CC	undefined	Transmission	Manual
Fuel Type	Petrol	Type of Body	Hatchback
Colour	White	Grade	undefined
Expiry Revenue license	06-04-2024	Expiry Insurance	06-04-2024

Body / Panel Condition

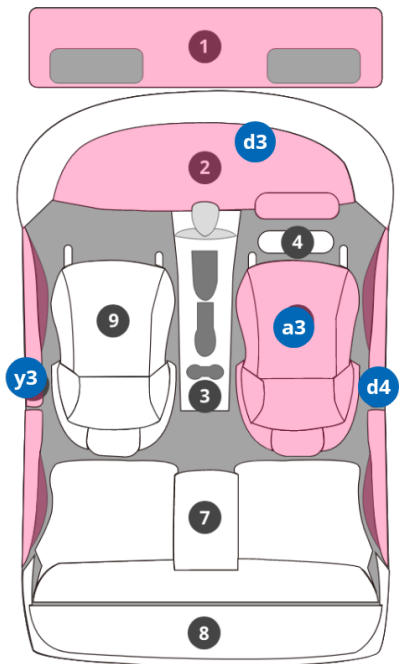
<p>Interior Evaluation : B-</p>	<p>Exterior Evaluation : B-</p>
<div style="text-align: center;">

</div> <p>a : Cut, Fray d : Loose, Deformed k : Animal Hair s : Smell t : Cigarette Burns x : Defective y : Stain</p>	<div style="text-align: center;">

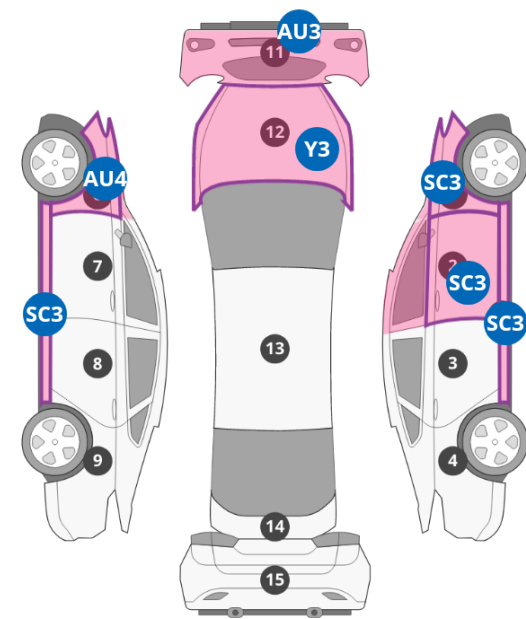
</div> <p>A : Scratch AU : Scratch & Dent B : Modified C : Corrosion G : Stone chip P : Faded S : Rust SC : Rust & Corrosion U : Dent X : Defective Y : Crack, Gap</p>
<p>Remarks Switches - Missing - Yes / Dashboard - Loose, Deformed, Grime - Medium / Right Front Trim - Loose, Deformed, Grime - Large / Left Front Trim - Grime - Medium / Right Front Seat - Cut, Crack - Medium</p>	<p>Remarks Right Front Door - Repair Traces - Yes / Right Step and Side Spoiler - Repair Traces - Yes / Right Front Fender - Repair Traces - Yes / Bonnet - Repair Traces - Yes / Left Front Fender - Repair Traces - Yes / Left Step and Side Spoiler - Repair Traces - Yes / Front Bumper and Grille - Scratch & Dent - Medium / Bonnet, Headlight - Crack, Gap - Medium / Right Front Fender - Rust, Corrosion - Medium / Right Front Wheel, Cover - Cap Missing - Yes / Right Front Door - Rust, Corrosion - Medium / Right Step and Side Spoiler - Rust, Corrosion - Medium / Left Front Fender - Scratch & Dent - Large / Left Step and Side Spoiler - Rust, Corrosion - Medium / Left Front Wheel, Cover - Cap Missing - Yes</p>
