## General Information

Date & Time: 01, Mar, 2024 12:44

Make	Honda	Model	City
YOM	2012	Mileage	281,957
Registration No.	LEC-12-6983	Chassis No.	NFBGM1643CR129704
CC	1.3	Transmission	Automatic
Fuel Type	Petrol	Type of Body	Sedan/Saloon
Colour	Silver	Grade	undefined
Expiry Revenue license	30-03-2024	Expiry Insurance	06-04-2024

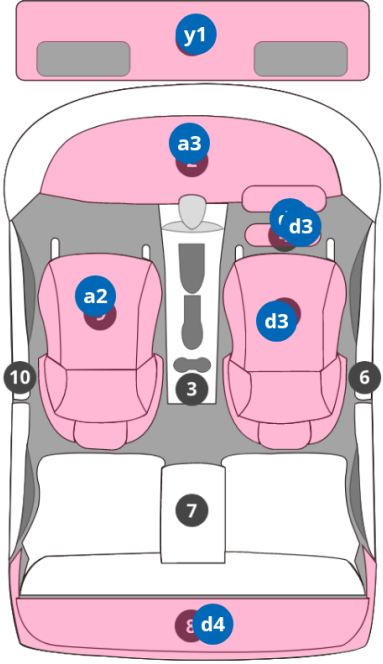
<b>Interior Evaluation :</b> <span style="float: right;"><b>B-</b></span>	<b>Exterior Evaluation :</b> <span style="float: right;"><b>B+</b></span>

<p><b>a</b> : Cut, Fray <b>d</b> : Loose, Deformed <b>k</b> : Animal Hair <b>s</b> : Smell <b>t</b> : Cigarette Burns <b>x</b> : Defective <b>y</b> : Stain</p>

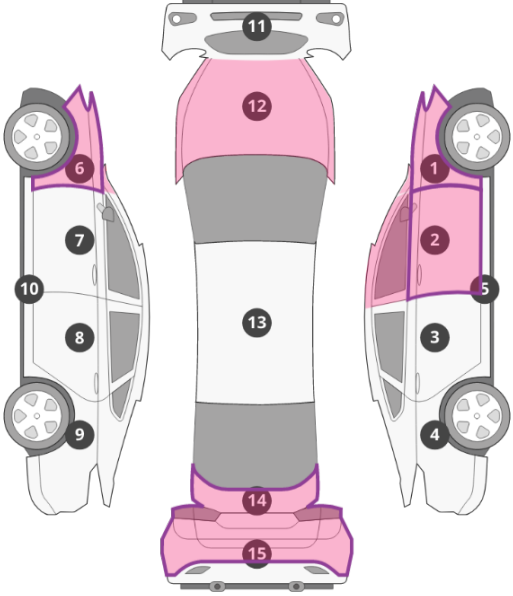
<p><b>A</b> : Scratch <b>AU</b> : Scratch &amp; Dent <b>B</b> : Modified <b>C</b> : Corrosion <b>G</b> : Stone chip <b>P</b> : Faded <b>S</b> : Rust <b>SC</b> : Rust &amp; Corrosion <b>U</b> : Dent <b>X</b> : Defective <b>Y</b> : Crack, Gap</p>
<p><b>Remarks</b> Ceiling - Grime - Minimal / Room Lamp - Stuck - Yes / Steering Wheel - Worn, Peel, Crack - Medium / Left Front Floor Lag - Crinkle - Medium / Right Front Floor Lag - Crinkle - Medium / Right Front Seat belt - Loose, Deformed, Grime - Medium / Left Front Seat belt - Cut, Crack - Small / Trunk Room - Loose, Deformed, Grime - Large</p>	<p><b>Remarks</b> Right Front Door - Repair Traces - Yes / Right Front Fender - Repair Traces - Yes / Bonnet - Repair Traces - Yes / Left Front Fender - Repair Traces - Yes / Trunk Hood, Rear Gate - Repair Traces - Yes</p>
