## General Information

Make	Suzuki	Model	Other
YOM	2017	Mileage	263,800
Registration No.	LEB-17A-7542	Chassis No.	NF1AVK31H10010109
CC	undefined	Transmission	Manual
Fuel Type	Petrol	Type of Body	Hatchback
Colour	White	Grade	undefined
Expiry Revenue license	06-04-2024	Expiry Insurance	06-04-2024

## Body / Panel Condition

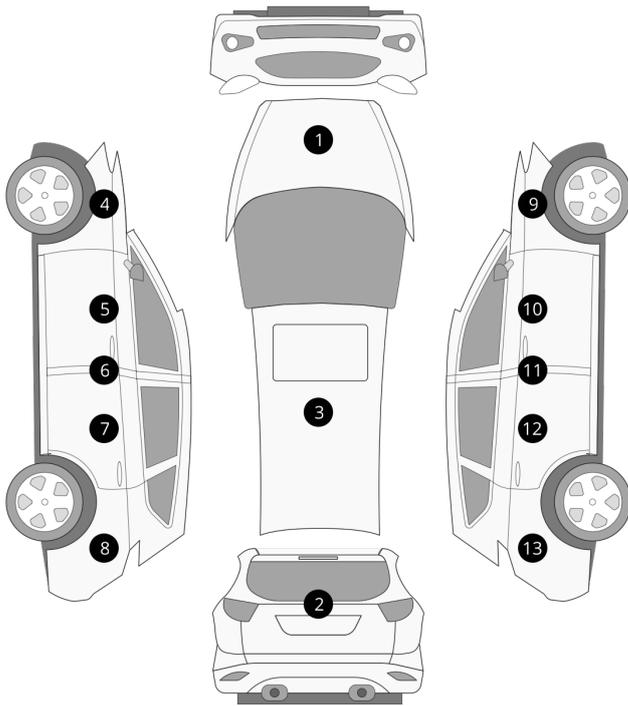
#	Area	Thickness(um)			
		Average	Value1	Value2	Value3/4
1	Bonnet	13.6	13	21	7
2	Boot Lid	4.8	6	4	4
3	Roof	4.2	5	4	4/4
4	Left Front Fender	12.6	14	19	5
5	Left Front Door	10.8	13	8	12
6	Center Panel Left				
7	Left Rear Door	13.0	16	10	13
8	Left Back Panel	39.9	46	34	40
9	Right Front Fender	3.9	6	5	1
10	Right Front Door	5.5	8	4	5
11	Center Panel Right				
12	Right Rear Door	11.0	5	4	24
13	Right Back Panel	24.0	37	25	10

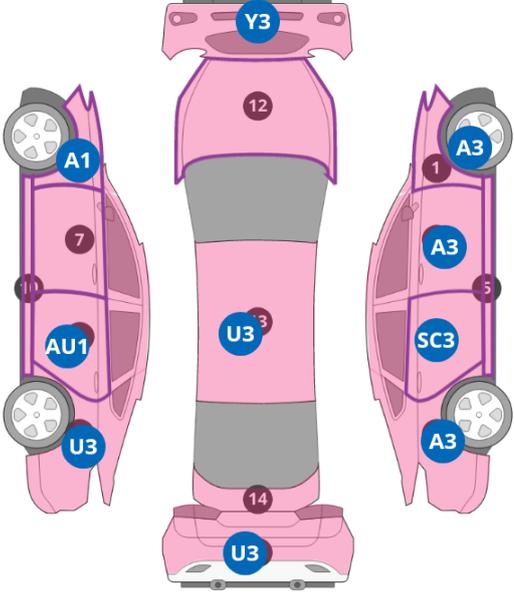
<p><b>A</b> : Scratch <b>AU</b> : Scratch &amp; Dent <b>B</b> : Modified <b>C</b> : Corrosion <b>G</b> : Stone chip <b>P</b> : Faded <b>S</b> : Rust <b>SC</b> : Rust &amp; Corrosion <b>U</b> : Dent <b>X</b> : Defective <b>Y</b> : Crack, Gap</p>
<p><b>Remarks</b> Sunvisor - Missing - Yes / Steering Wheel - Worn, Peel, Crack - Small / Carpet - Worn, Scratch, Cut, Crack - Medium / Right Front Seat - Cut, Crack - Large / Overall Interior - Worn as per age - Yes / Rear Seat - Cut, Crack - Medium / Trunk Room - Loose, Deformed, Grime - Medium</p>	<p><b>Remarks</b> Right Step and Side Spoiler - Repair Traces - Yes / Right Front Fender - Repair Traces - Yes / Bonnet - Repair Traces - Yes / Left Front Fender - Repair Traces - Yes / Left Front Door - Repair Traces - Yes / Left Step and Side Spoiler - Repair Traces - Yes / Left Rear Door - Repair Traces - Yes / Right Rear Door - Repair Traces - Yes / Right Front Fender - Scratch - Medium / Right Front Door - Scratch - Medium / Right Rear Fender - Scratch - Medium / Right Rear Door - Rust, Corrosion - Medium / Bonnet, Headlight - Partially Missing - Yes / Left Rear Fender - Dent - Medium / Left Rear Door - Scratch &amp; Dent - Minimal / Left Front Fender - Scratch - Minimal / Trunk Hood, Rear Gate - Dent - Medium / Roof - Dent - Medium / Front Bumper and Grille - Crack, Gap - Medium</p>
