General Information

Make	Suzuki	Model	Other
YOM	2018	Mileage	238,351
Registration No.	LEB-18-3088	Chassis No.	NF1AVK31H10016167
CC	undefined	Transmission	Manual
Fuel Type	Petrol	Type of Body	Hatchback
Colour	White	Grade	undefined
Expiry Revenue license	06-04-2024	Expiry Insurance	06-04-2024

Body / Panel Condition

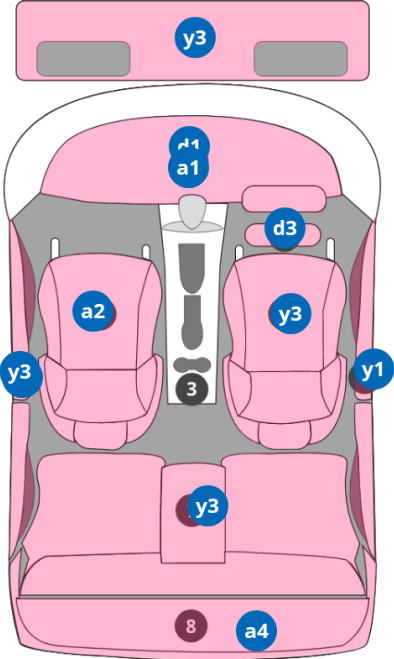
Interior Evaluation : C	Exterior Evaluation : D

<p>A : Scratch AU : Scratch & Dent B : Modified C : Corrosion G : Stone chip P : Faded S : Rust SC : Rust & Corrosion U : Dent X : Defective Y : Crack, Gap</p>
<p>Remarks Ceiling - Grime - Medium / Dashboard - Loose, Deformed, Grime - Minimal / Glove Box - Worn, Scratch, Cut, Crack - Minimal / Carpet - Loose, Deformed, Grime - Medium / Right Front Seat - Grime - Medium / Left Front Seat - Cut, Crack - Small / Right Front Trim - Grime - Minimal / Left Front Trim - Grime - Medium / Left Rear Trim - Grime - Medium / Rear Seat - Grime - Medium / Trunk Room - Worn, Scratch, Cut, Crack - Large</p>	<p>Remarks Right Front Door - Repair Traces - Yes / Right Front Fender - Repair Traces - Yes / Bonnet - Repair Traces - Yes / Left Front Door - Repair Traces - Yes / Left Step and Side Spoiler - Repair Traces - Yes / Left Rear Door - Repair Traces - Yes / Right Rear Door - Repair Traces - Yes / Right Front Fender - Crack, Gap - Medium / Supplemental Mirror - Scratch, Peeled - Minimal / Right Front Wheel, Cover - Scratch, Corrosion - Bent / Right Front Door - Dent - Minimal / Right Rear Door - Scratch - Minimal / Right Rear Fender - Scratch - Large / Left Rear Fender - Dent - Large / Left Rear Door - Dent - Large / Left Step and Side Spoiler - Dent - Large / Front Bumper and Grille - Crack, Gap - Medium / Bonnet, Headlight - Dent - Minimal / Trunk Hood, Rear Gate - Dent - Minimal / Rear Bumper, Lamps, Panels - Scratch - Small</p>
