General Information

Date & Time: 01, Mar, 2024 13:16

Make	Suzuki	Model	Other
YOM	2018	Mileage	189,816
Registration No.	BPN-847	Chassis No.	10038424
CC	undefined	Transmission	Manual
Fuel Type	Petrol	Type of Body	Hatchback
Colour	White	Grade	undefined
Expiry Revenue license	06-04-2024	Expiry Insurance	06-04-2024

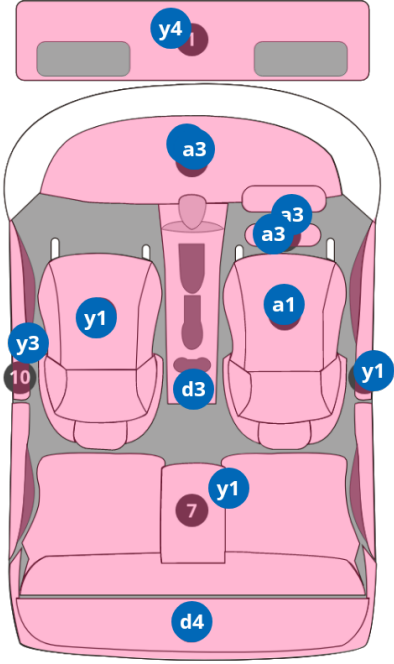
Interior Evaluation : C	Exterior Evaluation : D

<p>a : Cut, Fray d : Loose, Deformed k : Animal Hair s : Smell t : Cigarette Burns x : Defective y : Stain</p>

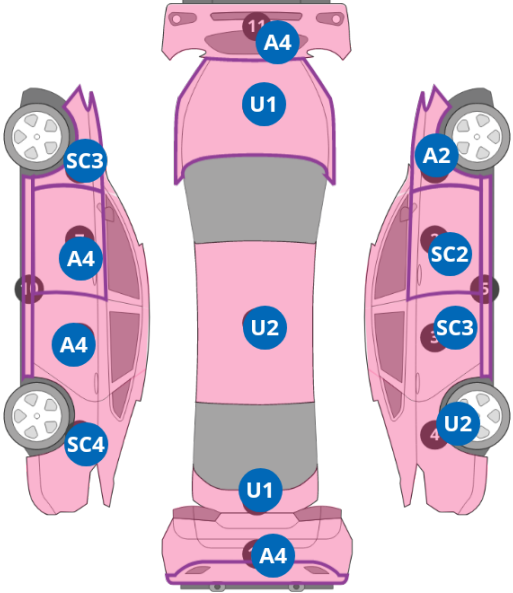
<p>A : Scratch AU : Scratch & Dent B : Modified C : Corrosion G : Stone chip P : Faded S : Rust SC : Rust & Corrosion U : Dent X : Defective Y : Crack, Gap</p>
<p>Remarks Ceiling - Grime - Large / Dashboard - Worn, Scratch, Cut, Crack - Minimal / Steering Wheel - Worn, Peel, Crack - Medium / Right Front Floor Lag - Cut, Crack - Medium / Left Front Floor Lag - Cut, Crack - Medium / Console - Loose, Deformed, Grime - Medium / Right Front Seat - Fray - Minimal / Right Rear Trim - Grime - Minimal / Rear Seat - Grime - Minimal / Trunk Room - Loose, Deformed, Grime - Large / Left Front Seat - Grime - Minimal / Left Front Trim - Grime - Medium</p>	<p>Remarks Right Front Door - Repair Traces - Yes / Right Step and Side Spoiler - Repair Traces - Yes / Right Front Fender - Repair Traces - Yes / Bonnet - Repair Traces - Yes / Left Front Fender - Repair Traces - Yes / Left Front Door - Repair Traces - Yes / Left Step and Side Spoiler - Repair Traces - Yes / Left Rear Door - Repair Traces - Yes / Trunk Hood, Rear Gate - Repair Traces - Yes / Rear End Panel - Repair Traces - Yes / Right Rear Door - Repair Traces - Yes / Right Front Fender - Scratch - Small / Right Front Door - Rust, Corrosion - Small / Right Rear Door - Rust, Corrosion - Medium / Right Rear Fender - Dent - Small / Left Front Fender - Rust, Corrosion - Medium / Left Rear Door - Scratch - Large / Left Front Door - Scratch - Large / Left Rear Fender - Rust, Corrosion - Large / Front Bumper and Grille - Scratch - Large / Bonnet, Headlight - Dent - Minimal / Roof - Dent - Small / Trunk Hood, Rear Gate - Dent - Minimal / Rear Bumper, Lamps, Panels - Scratch - Large</p>
