General Information

Date & Time: 02, Mar, 2024 10:26

Make	Suzuki	Model	Other
YOM	2019	Mileage	222,130
Registration No.	LEH-19-4991	Chassis No.	NF1AVK31H10047940
CC	undefined	Transmission	Manual
Fuel Type	Petrol	Type of Body	Hatchback
Colour	White	Grade	undefined
Expiry Revenue license	06-04-2024	Expiry Insurance	06-04-2024

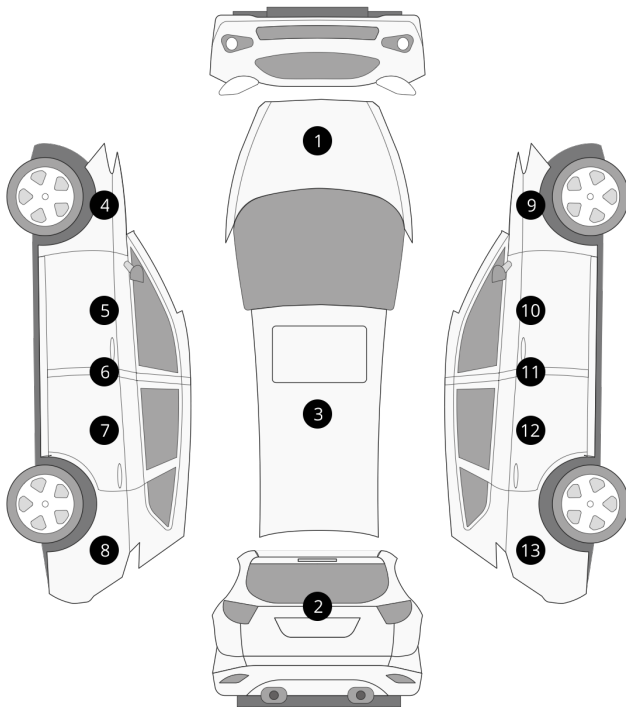
Body / Panel Condition

#	Area	Thickness(um)			
		Average	Value1	Value2	Value3/4
1	Bonnet	3.8	4	5	3
2	Boot Lid	3.1	3	3	3
3	Roof	3.1	3	3	3/3
4	Left Front Fender	3.5	4	3	4
5	Left Front Door	3.3	4	3	3
6	Center Panel Left				
7	Left Rear Door	3.3	4	3	3
8	Left Back Panel	3.7	4	4	3
9	Right Front Fender	2.9	3	3	3
10	Right Front Door	2.8	3	3	3
11	Center Panel Right				
12	Right Rear Door	2.9	3	3	3
13	Right Back Panel	3.1	3	3	3

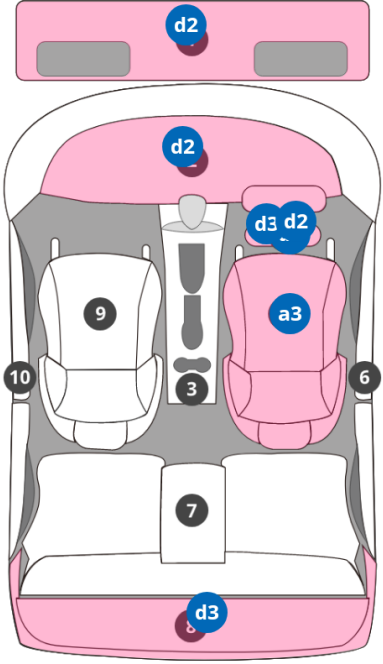
Interior Evaluation : B	Exterior Evaluation : B+

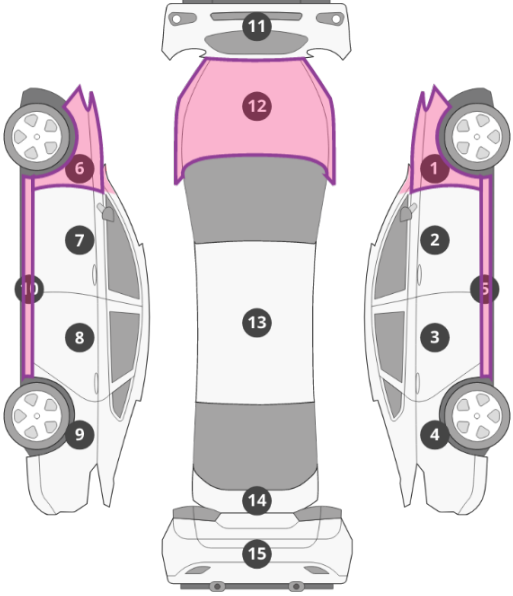
<p>A : Scratch AU : Scratch & Dent B : Modified C : Corrosion G : Stone chip P : Faded S : Rust SC : Rust & Corrosion U : Dent X : Defective Y : Crack, Gap</p>
<p>Remarks Ceiling - Crinkle - Small / Carpet - Loose, Deformed, Grime - Small / Right Front Floor Lag - Loose, Deformed, Grime - Medium / Left Front Floor Lag - Loose, Deformed, Grime - Small / Right Front Seat - Cut, Crack - Medium / Trunk Room - Loose, Deformed, Grime - Medium</p>	<p>Remarks Right Step and Side Spoiler - Repair Traces - Yes / Right Front Fender - Repair Traces - Yes / Bonnet - Repair Traces - Yes / Left Front Fender - Repair Traces - Yes / Left Step and Side Spoiler - Repair Traces - Yes</p>
Frame Evaluation : B	Functional Evaluation : C
<p>Remarks Center Floor Panel - Bulge (Cuts, Major Deforms) or Corrosion ? - Yes</p>	<p>Remarks Power Window (each) - Stuck, Gap - Yes / Air Conditioner - Function - Weak / Battery - Weak - Yes / Audio, Radio - Issue - Yes / Reverse Camera - N/A - Yes / Wiper - Function - Weak</p>
