## General Information

Date & Time: 15, Feb, 2024 17:10

Make	Suzuki	Model	Other
YOM	2016	Mileage	44,409
Registration No.	BGP-120	Chassis No.	SF410PK533004
CC	undefined	Transmission	Manual
Fuel Type	Petrol	Type of Body	Hatchback
Colour	Gold	Grade	undefined
Expiry Revenue license	15-03-2024	Expiry Insurance	15-03-2024

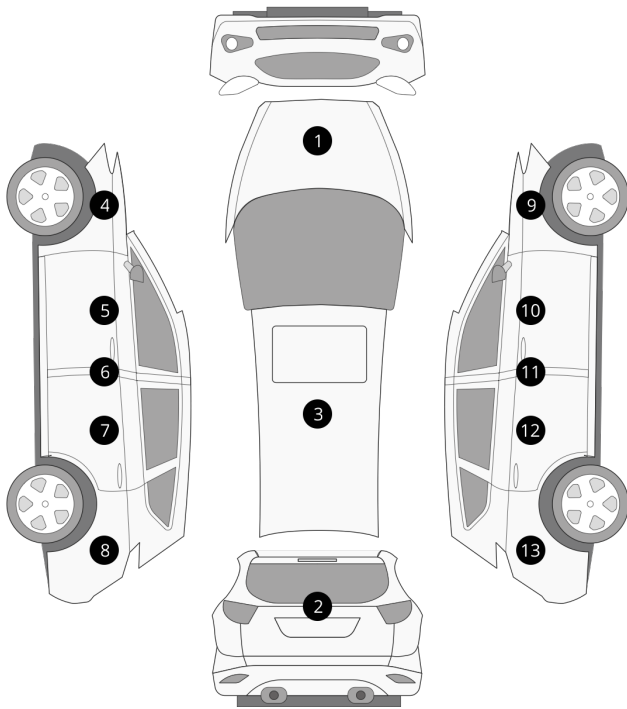
## Body / Panel Condition

#	Area	Thickness(um)			
		Average	Value1	Value2	Value3/4
1	Bonnet	4.8	4	6	4
2	Boot Lid	4.3	4	5	5
3	Roof	3.7	4	5	2/4
4	Left Front Fender	5.1	5	5	5
5	Left Front Door	3.4	3	3	3
6	Center Panel Left				
7	Left Rear Door	2.5	4	4	0
8	Left Back Panel	4.5	5	4	4
9	Right Front Fender	4.0	4	4	4
10	Right Front Door	8.1	10	7	7
11	Center Panel Right				
12	Right Rear Door	15.6	15	16	16
13	Right Back Panel	12.4	12	11	15

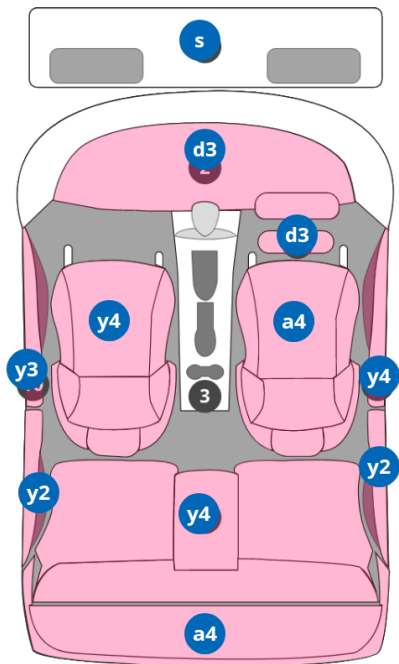
<b>Interior Evaluation :</b> <span style="float: right;"><b>D</b></span>	<b>Exterior Evaluation :</b> <span style="float: right;"><b>D</b></span>

<p><b>a</b> : Cut, Fray <b>d</b> : Loose, Deformed <b>k</b> : Animal Hair <b>s</b> : Smell <b>t</b> : Cigarette Burns <b>x</b> : Defective <b>y</b> : Stain</p>

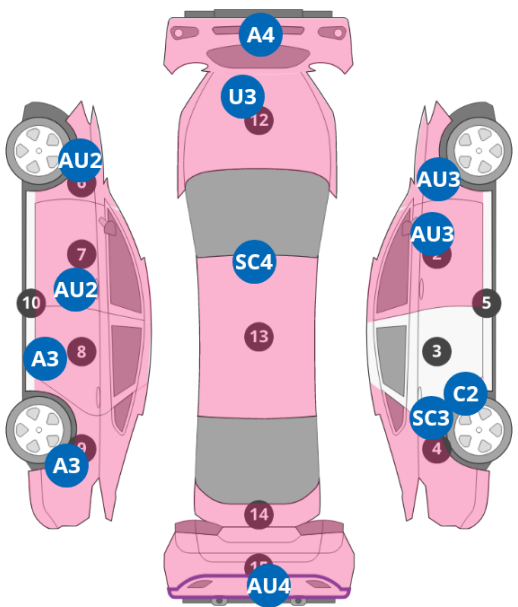
<p><b>A</b> : Scratch <b>AU</b> : Scratch &amp; Dent <b>B</b> : Modified <b>C</b> : Corrosion <b>G</b> : Stone chip <b>P</b> : Faded <b>S</b> : Rust <b>SC</b> : Rust &amp; Corrosion <b>U</b> : Dent <b>X</b> : Defective <b>Y</b> : Crack, Gap</p>
<p><b>Remarks</b> Overall Interior - Smell - Yes / Dashboard - Loose, Deformed, Grime - Medium / Right Front Floor Lag - Loose, Deformed, Grime - Medium / Right Front Seat - Cut, Crack - Large / Right Front Trim - Grime - Large / Right Rear Trim - Grime - Small / Rear Seat - Grime - Large / Left Front Seat - Grime - Large / Left Front Trim - Grime - Medium / Left Rear Trim - Grime - Small / Trunk Room - Worn, Scratch, Cut, Crack - Large</p>	<p><b>Remarks</b> Right Front Fender - Repair Traces - Yes / Bonnet - Repair Traces - Yes / Trunk Hood, Rear Gate - Repair Traces - Yes / Rear End Panel - Repair Traces - Yes / Right Front Fender - Scratch &amp; Dent - Medium / Right Front Door - Scratch &amp; Dent - Medium / Right Rear Wheel, Cover - Scratch, Corrosion - Small / Right Rear Fender - Rust, Corrosion - Medium / Rear Bumper, Lamps, Panels - Scratch &amp; Dent - Large / Left Rear Fender - Scratch - Medium / Left Rear Door - Scratch - Medium / Left Front Door - Scratch &amp; Dent - Small / Left Front Fender - Scratch &amp; Dent - Small / Roof - Rust, Corrosion - Large / Bonnet, Headlight - Dent - Medium / Front Bumper and Grille - Scratch - Large</p>
