General Information

| Make | Toyota | Model | Corolla |
| Registration No. | LE-11-1344 | Chassis No. | NZE1402121258 |

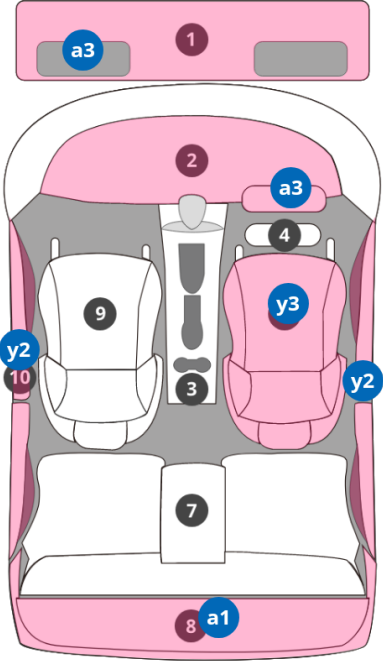
| Interior Evaluation : B- | Exterior Evaluation : B |

| <p>Remarks Sunvisor - Cut, Crack - Minimal / Steering Wheel - Worn, Peel, Crack - Medium / Right Front Seat - Grime - Medium / Left Front Trim - Grime - Medium / Right Front Trim - Grime - Medium / Console - Loose, Deformed, Grime - Minimal / Trunk Room - Loose, Deformed, Grime - Medium</p> | <p>Remarks Front Bumper and Grille - Scratch - Minimal / Bonnet, Headlight - Scratch - Minimal / Right Front Fender - Scratch - Minimal / Right Front Door - Scratch - Small / Right Rear Door - Scratch - Minimal / Right Rear Fender - Dent - Minimal / Rear Bumper, Lamps, Panels - Repair mark - Yes / Trunk Hood, Rear Gate - Scratch - Small / Left Rear Door - Scratch - Minimal / Left Rear Fender - Scratch - Minimal / Left Front Door - Dent - Small / Left Front Fender - Scratch - Minimal</p> |
