General Information

Make	Toyota	Model	Corolla
YOM	2014	Mileage	187,024
Registration No.	LED-14-2334	Chassis No.	ZRE172R-7001517
CC	undefined	Transmission	Automatic
Fuel Type	Petrol	Type of Body	Sedan/Saloon
Colour	White	Grade	undefined
Expiry Revenue license		Expiry Insurance

Body / Panel Condition

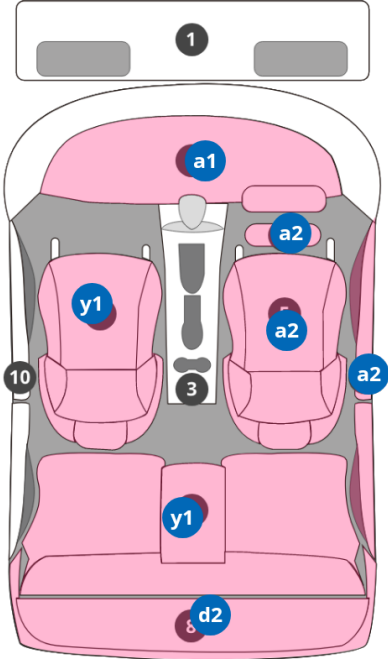
Interior Evaluation : B	Exterior Evaluation : B

<p>a : Cut, Fray d : Loose, Deformed k : Animal Hair s : Smell t : Cigarette Burns x : Defective y : Stain</p>

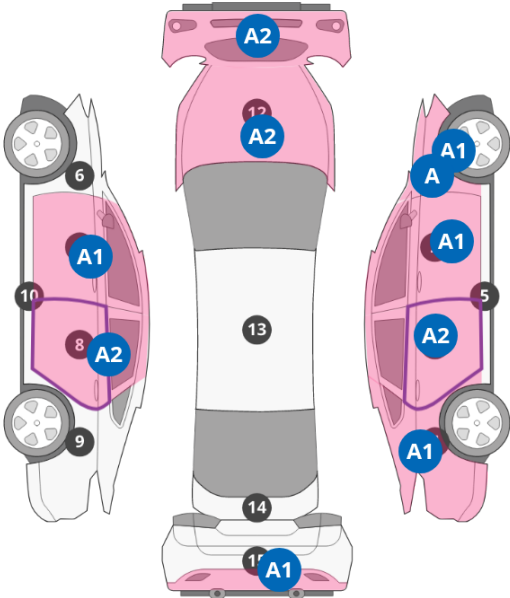
<p>A : Scratch AU : Scratch & Dent B : Modified C : Corrosion G : Stone chip P : Faded S : Rust SC : Rust & Corrosion U : Dent X : Defective Y : Crack, Gap</p>
<p>Remarks Instrument Panel - Worn, Scratch, Cut, Crack - Minimal / Carpet - Worn, Scratch, Cut, Crack - Small / Right Front Seat - Cut, Crack - Small / Right Front Trim - Cut, Crack - Small / Rear Seat - Grime - Minimal / Trunk Room - Loose, Deformed, Grime - Small / Left Front Seat - Grime - Minimal</p>	<p>Remarks Left Front Door - Repair Traces - Yes / Left Rear Door - Repair Traces - Yes / Right Rear Door - Repair Traces - Yes / Right Front Fender - Scratch - Minimal / Supplemental Mirror - Scratch, Peeled - Yes / Right Front Door - Scratch - Minimal / Right Rear Door - Scratch - Small / Right Rear Fender - Scratch - Minimal / Left Front Door - Scratch - Minimal / Left Rear Door - Scratch - Small / Front Bumper and Grille - Scratch - Small / Bonnet, Headlight - Scratch - Small / Rear Bumper, Lamps, Panels - Scratch - Minimal</p>
