General Information

Make	Toyota	Model	Corolla
YOM	2021	Mileage	67,122
Registration No.	AHB-090	Chassis No.	ZRE171R-6063732
CC	1.6	Transmission	Automatic
Fuel Type	Petrol	Type of Body	Sedan/Saloon
Colour	Black	Grade	undefined
Expiry Revenue license		Expiry Insurance

Body / Panel Condition

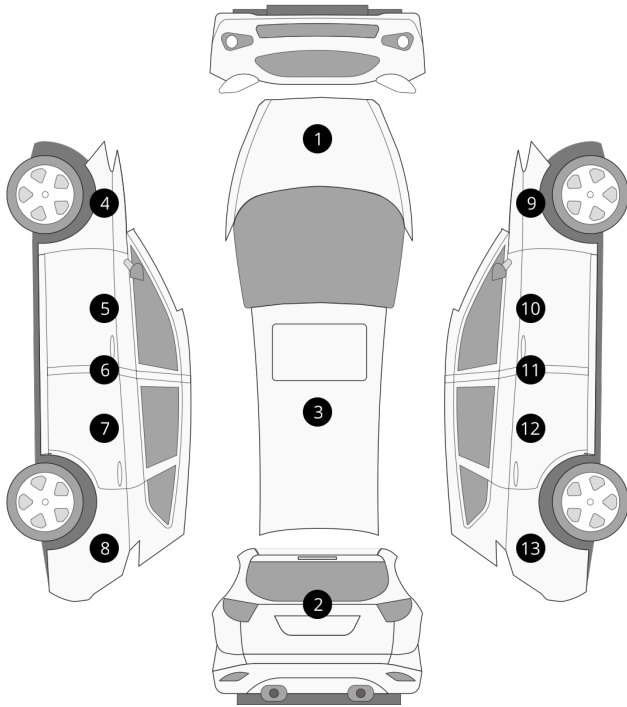
#	Area	Thickness(um)			
		Average	Value1	Value2	Value3/4
1	Bonnet	167.3	129	206	167
2	Boot Lid	110.6	102	125	105
3	Roof	113.2	112	119	107/115
4	Left Front Fender	156.6	152	149	169
5	Left Front Door	140.0	140	144	136
6	Center Panel Left				
7	Left Rear Door	137.3	136	138	138
8	Left Back Panel	175.0	132	233	160
9	Right Front Fender	124.6	122	126	126
10	Right Front Door	136.6	140	142	128
11	Center Panel Right				
12	Right Rear Door	118.2	78	149	128
13	Right Back Panel	145.0	119	146	170

Interior Evaluation :	B+	Exterior Evaluation :	B
<p>a : Cut, Fray d : Loose, Deformed k : Animal Hair s : Smell t : Cigarette Burns x : Defective y : Stain</p>		<p>A : Scratch AU : Scratch & Dent B : Modified C : Corrosion G : Stone chip P : Faded S : Rust SC : Rust & Corrosion U : Dent X : Defective Y : Crack, Gap</p>	
<p>Remarks Console - Loose, Deformed, Grime - Minimal / Right Front Seat - Grime - Minimal / Rear Seat - Grime - Minimal / Left Front Seat - Grime - Minimal</p>		<p>Remarks Bonnet - Repair Traces - Yes / Left Rear Fender - Repair Traces - Yes / Right Rear Door - Repair Traces - Yes / Right Front Fender - Scratch - Minimal / Right Front Door - Dent - Minimal / Right Rear Door - Dent - Minimal / Right Rear Fender - Dent - Small / Left Front Door - Scratch - Small / Right Step and Side Spoiler - Scratch - Small / Trunk Hood, Rear Gate - Dent - Minimal / Front Bumper and Grille - Scratch - Minimal</p>
