General Information

Make	Toyota	Model	Corolla
YOM	2009	Mileage	36,756
Registration No.	ASW-251	Chassis No.	ZZE1427403857
CC	undefined	Transmission	Automatic
Fuel Type	Petrol	Type of Body	Sedan/Saloon
Colour	Silver	Grade	undefined
Expiry Revenue license	16-03-2024	Expiry Insurance	16-03-2024

Body / Panel Condition

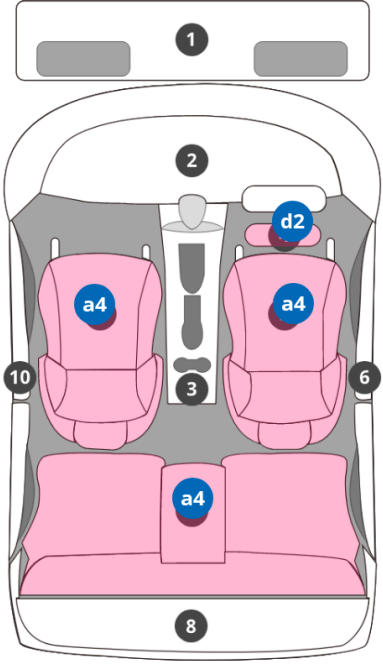
Interior Evaluation : B-	Exterior Evaluation : B+

<p>a : Cut, Fray d : Loose, Deformed k : Animal Hair s : Smell t : Cigarette Burns x : Defective y : Stain</p>

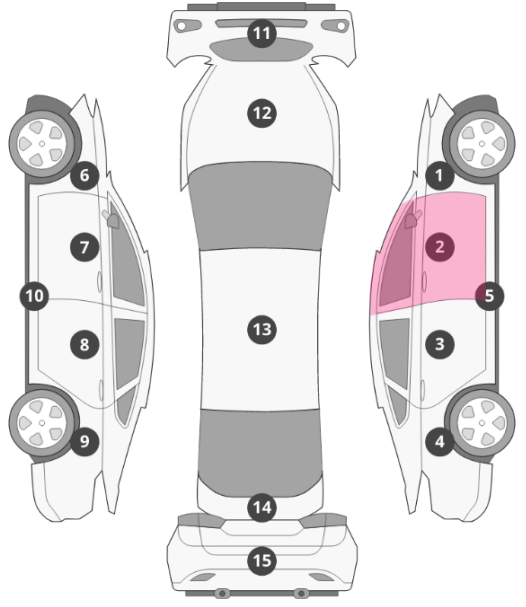
<p>A : Scratch AU : Scratch & Dent B : Modified C : Corrosion G : Stone chip P : Faded S : Rust SC : Rust & Corrosion U : Dent X : Defective Y : Crack, Gap</p>
<p>Remarks Overall Interior - Worn as per age - Yes / Carpet - Loose, Deformed, Grime - Small / Right Front Seat - Cut, Crack - Large / Left Front Seat - Cut, Crack - Large / Rear Seat - Cut, Crack - Large</p>	<p>Remarks Right Front Door - Repair Traces - Yes</p>
Frame Evaluation : B+	Functional Evaluation : B-
<p>Remarks Defects not found</p>	<p>Remarks Air Conditioner - Function - Weak / Battery - Weak - Yes</p>
