General Information

Make	Toyota	Model	Yaris
YOM	2020	Mileage	92,742
Registration No.	AAB-174	Chassis No.	NSP150R-7002712
CC	1.3	Transmission	Automatic
Fuel Type	Petrol	Type of Body	Sedan/Saloon
Colour	Gray	Grade	undefined
Expiry Revenue license		Expiry Insurance

Body / Panel Condition

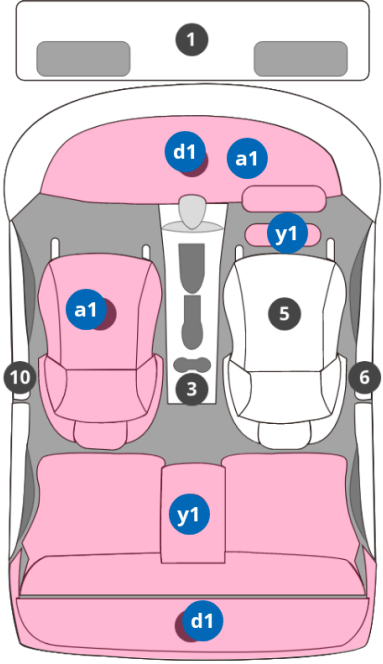
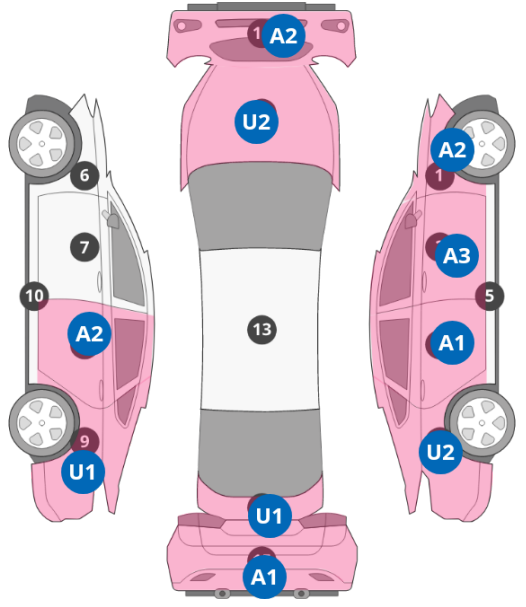
Interior Evaluation : B+	Exterior Evaluation : B

<p>a : Cut, Fray d : Loose, Deformed k : Animal Hair s : Smell t : Cigarette Burns x : Defective y : Stain</p>	<p>A : Scratch AU : Scratch & Dent B : Modified C : Corrosion G : Stone chip P : Faded S : Rust SC : Rust & Corrosion U : Dent X : Defective Y : Crack, Gap</p>
<p>Remarks Glove Box - Loose, Deformed, Grime - Minimal / Instrument Panel - Worn, Scratch, Cut, Crack - Minimal / Right Front Floor Lag - Grime - Minimal / Left Front Seat - Fray - Minimal / Rear Seat - Grime - Minimal / Trunk Room - Loose, Deformed, Grime - Minimal</p>	<p>Remarks Right Front Fender - Scratch - Small / Right Front Door - Scratch - Medium / Right Rear Door - Scratch - Minimal / Right Rear Fender - Dent - Small / Left Rear Door - Scratch - Small / Left Rear Fender - Dent - Minimal / Front Bumper and Grille - Scratch - Small / Bonnet, Headlight - Dent - Small / Trunk Hood, Rear Gate - Dent - Minimal / Rear Bumper, Lamps, Panels - Scratch - Minimal</p>
