## General Information

<b>Make</b>	Kia	<b>Model</b>	Other
<b>YOM</b>	2021	<b>Mileage</b>	19,002
<b>Registration No.</b>	AGZ-664	<b>Chassis No.</b>	KNHNC374MN6142765
<b>CC</b>	undefined	<b>Transmission</b>	Automatic
<b>Fuel Type</b>	Petrol	<b>Type of Body</b>	MPV
<b>Colour</b>	White	<b>Grade</b>	undefined
<b>Expiry Revenue license</b>		<b>Expiry Insurance</b>

## Body / Panel Condition

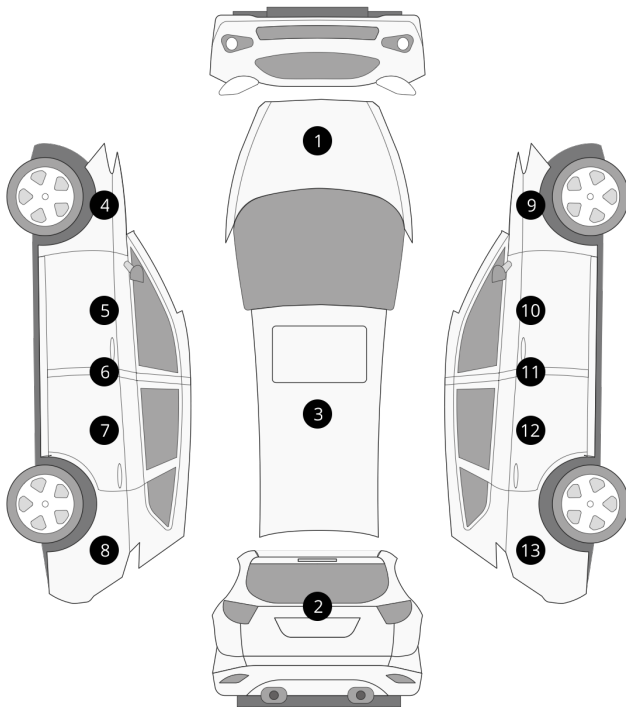
#	Area	Thickness(um)			
		Average	Value1	Value2	Value3/4
1	Bonnet	5.8	6	6	6
2	Boot Lid	5.2	5	5	6
3	Roof	5.6	5	5	6/6
4	Left Front Fender	7.2	9	8	5
5	Left Front Door	5.6	6	6	5
6	Center Panel Left				
7	Left Rear Door	5.6	6	6	5
8	Left Back Panel	6.2	6	6	7
9	Right Front Fender	5.4	5	6	5
10	Right Front Door	3.5	4	1	6
11	Center Panel Right				
12	Right Rear Door	12.6	6	27	6
13	Right Back Panel	8.9	7	6	14

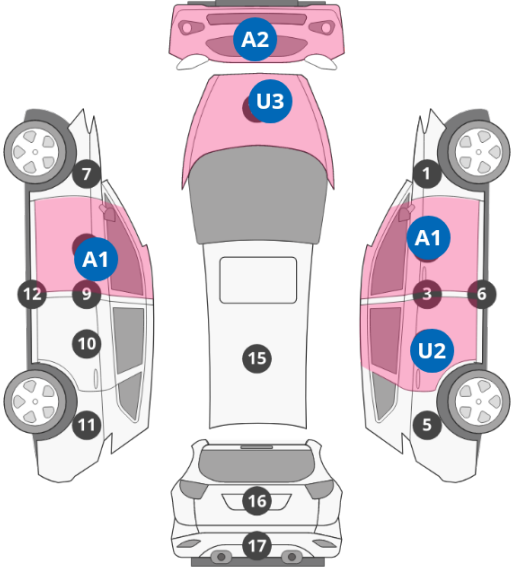
<p><b>A</b> : Scratch <b>AU</b> : Scratch &amp; Dent <b>B</b> : Modified <b>C</b> : Corrosion <b>G</b> : Stone chip <b>P</b> : Faded <b>S</b> : Rust <b>SC</b> : Rust &amp; Corrosion <b>U</b> : Dent <b>X</b> : Defective <b>Y</b> : Crack, Gap</p>
<b>Remarks</b> Defects not found	<b>Remarks</b> Right Front Door - Scratch - Minimal / Right Rear Door - Dent - Small / Left Front Door - Scratch - Minimal / Bonnet, Headlight - Dent - Medium / Front Bumper and Grille - Scratch - Small
<b>Frame Evaluation :</b> <span style="float: right;"><b>B+</b></span>	<b>Functional Evaluation :</b> <span style="float: right;"><b>B+</b></span>
