General Information

Make	Toyota	Model	Corolla
YOM	2019	Mileage	62,085
Registration No.	BQG-844	Chassis No.	ZRE171R6036837
CC	1.6	Transmission	Manual
Fuel Type	Petrol	Type of Body	Sedan/Saloon
Colour	White	Grade	undefined
Expiry Revenue license	22-03-2024	Expiry Insurance	23-03-2024

Body / Panel Condition

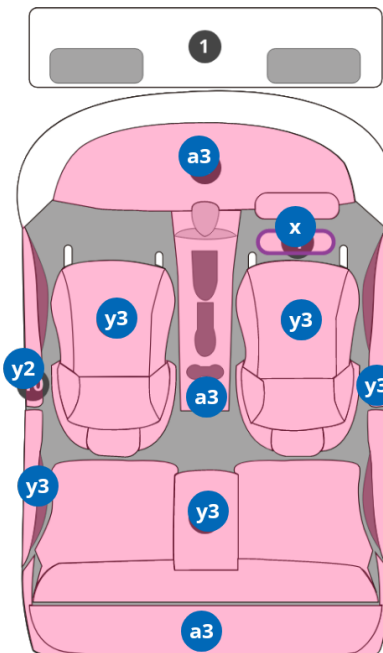
Interior Evaluation : C	Exterior Evaluation : B+
<div style="text-align: center;">

</div> <p>a : Cut, Fray d : Loose, Deformed k : Animal Hair s : Smell t : Cigarette Burns x : Defective y : Stain</p>	<div style="text-align: center;">

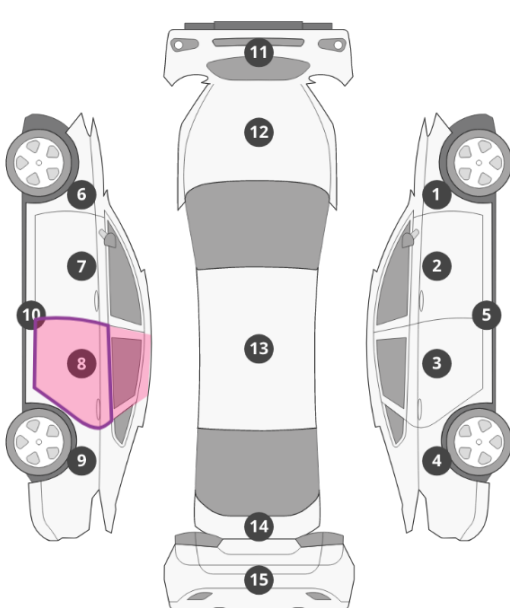
</div> <p>A : Scratch AU : Scratch & Dent B : Modified C : Corrosion G : Stone chip P : Faded S : Rust SC : Rust & Corrosion U : Dent X : Defective Y : Crack, Gap</p>
<p>Remarks Overall Interior - Worn as per age - Yes / Steering Wheel - Worn, Peel, Crack - Medium / Right Front Floor Lag - Missing - Yes / Right Front Seat - Grime - Medium / Left Front Seat - Grime - Medium / Console - Worn, Scratch, Cut, Crack - Medium / Rear Seat - Grime - Medium / Trunk Room - Worn, Scratch, Cut, Crack - Medium / Right Front Trim - Grime - Medium / Left Front Trim - Grime - Small / Left Rear Trim - Grime - Medium</p>	<p>Remarks Left Rear Door - Repair Traces - Yes</p>

<p>Inspector Notes</p>
<p>left side rear door paint marks</p>
